REPLACEMENT THERMOSTAT COVER

THIS EFFECTS EARLY SHIRE ENGINES WITH BASE 3TNE BLOCKS

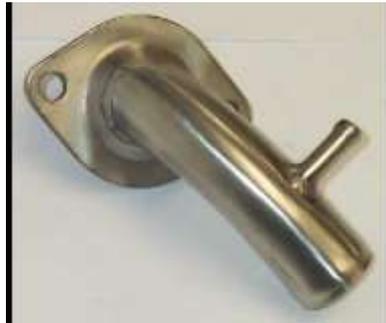
ORIGINAL COVER REPLACEMENT NLA: RDG2579

The original thermostat housing of RDG2579 is now no longer available and will need to be repaired/replaced by the below.

1. Repair the old one.
2. Get a new one made using the old one as a pattern
3. Due to the reorientation of the mounting holes you will need to fit the new housing (as above) and change/re-route the hoses on the boat to match the outlet position. Plus you will need the normal Yanmar gasket (129795-49551) and a ¼" BSP M/F elbow in the top to a ¼" BSP to 5/16" hose tail to fit the leak off hose to.
